Jacob Riis Houses

Existing Conditions Report

January 29, 2025, Final Draft

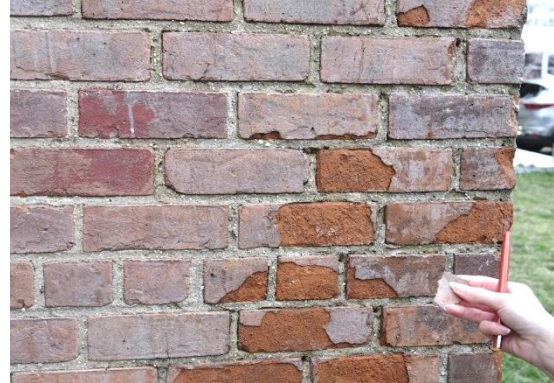
2.1.2. Exterior Masonry: bricks that absorb excess water are subject to spalling, a condition where water in the brick expands as it freezes, causing the saturated portion to fail and break off. NW has observed significant areas of spalling brick located at the buildings, particularly the buildings located adjacent to the FDR Drive.

Spalling at Building 4

Measures should be taken at these conditions to protect the public, such as the installation of temporary netting to restrain the masonry at the corners or areas of spalling, or erection of temporary fencing or sidewalk sheds to keep pedestrians away from potential falling masonry. As of the date of this report, sidewalk shed and fence have been installed at Building #5.

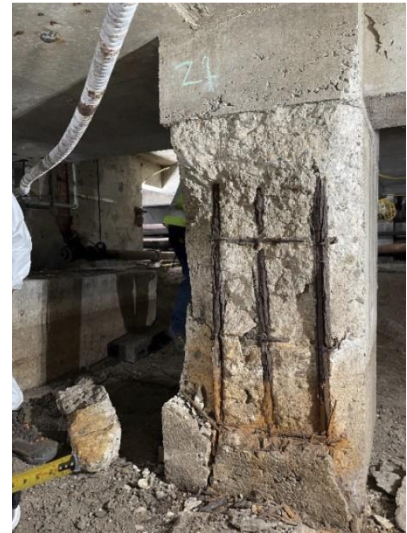
2.1.1. Deterioration in Crawlspace columns: NW's surveying has identified and learned of potentially hazardous conditions at Riis Houses. These include the deterioration of concrete columns, beams, and slabs in the crawl spaces and basements of (12) of the (19) buildings as reported to NYCHA in the Hurricane Sandy R+R project by YAS Structural Engineers. (7) of the buildings were identified as having "Priority 1" conditions that require immediate attention. These are Buildings 5, 9, 11, 13, 14, 15, and 18. Of these, emergency shoring has been installed in (4) of the buildings, Buildings 9, 11, 15, and 18, with work planned for the remainder of the high priority buildings.

Deteriorated concrete at Building 9 crawlspace – photo by YAS

Temporary shoring should be put in place at deteriorated concrete structural conditions for the balance of Priority 1 conditions (Buildings 5, 13, and 14). All buildings with Priority 1 conditions have had their respective filings approved by the NYC DOB to perform the work

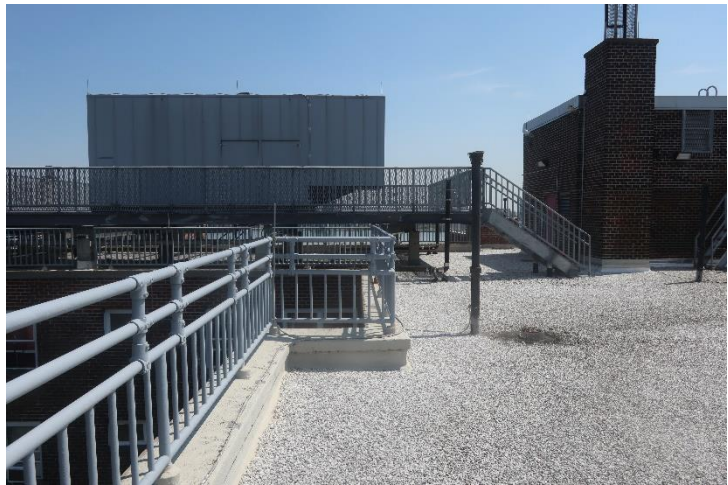
The roofs at Riis II are a hot-applied mod-bitumen ballasted roof assembly over tapered insulation. From NW's observations, all these roofs appear to be in good condition. Roof work according to as-built drawings for Hurricane Sandy R+R work was limited to immediately around where new penetrations were created to install the generators.

Building 14 roof (Riis II)

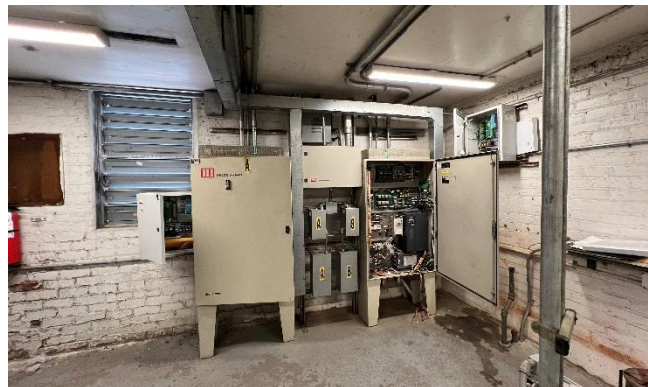
The interior of the elevator machine room is relatively clean. One of the exterior walls shows evidence of water penetration. This is directly below the A/C sleeve penetration, which may be the source of water penetration. No evidence of water penetration was visible at the underside of the roof slab. The motorized damper at the interior of the fan appears to be new and in good condition.

Building 5 Elevator Machine Room

The underside of the landing for the elevator machine room shows water staining and a loss of cement paste at the exposed surface as would be expected after 77+ years exposure. However, neither cracks nor other signs of impending failure were observed.

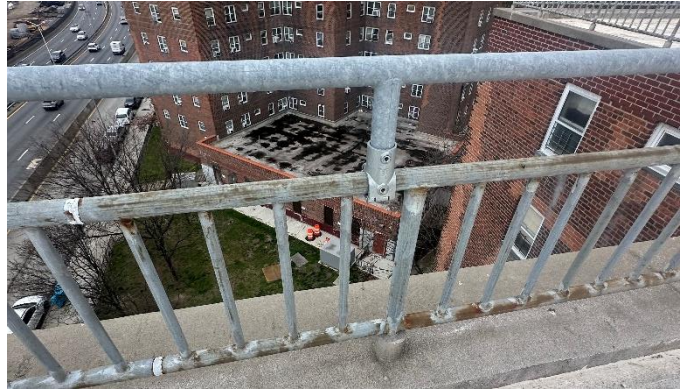
Within the Jacob Riis Houses Community Planning Process, residents reported that leaks at the top floor apartments in all the buildings increased notably when the parapets were replaced.

Guardrail extension

NW anticipates that parapets and railings will have to be replaced yet again to eliminate these ongoing problems.

NW notes that parapet replacement will require removal of the perimeter of the roof assembly. It will be necessary to work with the existing roof manufacturer to maintain the existing guarantee and obtain a guarantee for the new roof perimeter.

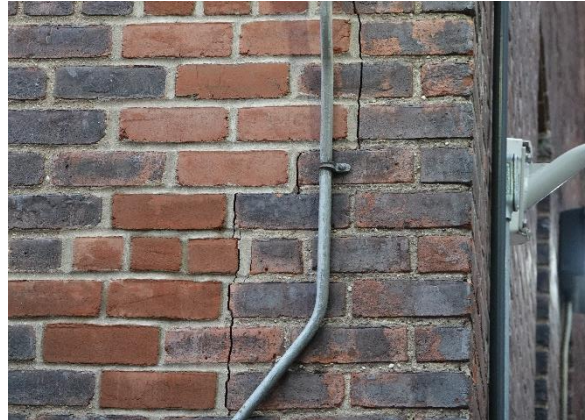
NW identified vertical cracks at corners where probes have shown that original masonry ties have corroded away, leaving these corners at risk of failure.

NW worked with NYCHA to perform probes by removing bricks from two locations in the development, at Building 5 where there is an existing crack,

New crack at a previously repaired corner

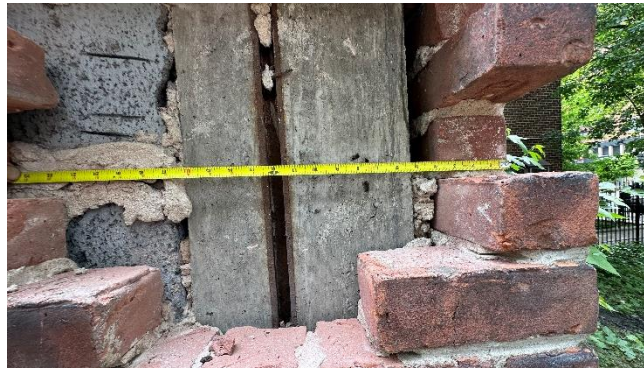
At both probes, the galvanized ties that connect the face brick back to the concrete columns at the corner were observed to be rusted away entirely. NW

Corroded tie at Building 17

anticipates that this is the case for all the ties between the brick and the columns. Where vertical cracks occur, particularly at both sides of a corner, this creates a potentially hazardous condition, described above under *Potentially Hazardous Conditions, 2.1.2.*

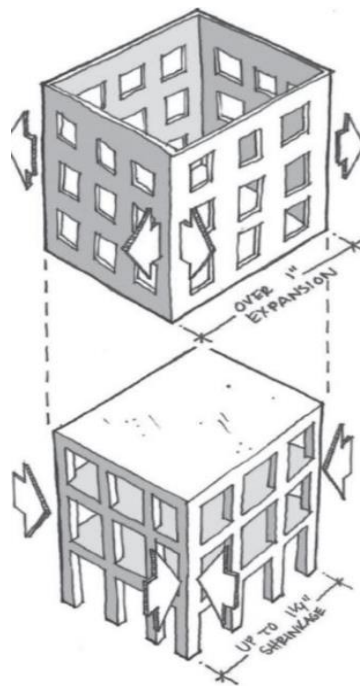
On old buildings, like those at Riis Houses, the original brick has already completed most of its irreversible expansion. Thus, if new brick is put into an existing exterior wall, the new brick will expand, while the old brick no longer does, causing repair-induced failures like those NW has observed at Riis Building 5. This makes "in-kind" repairs, like those performed in the past at Riis so problematic. Only a systemic repair designed to allow for expansion of the exterior brick masonry, and restoring attachment of the face brick to the columns and backup masonry will effectively address these problems for the long term.

Differential movement as explained by the above illustration.

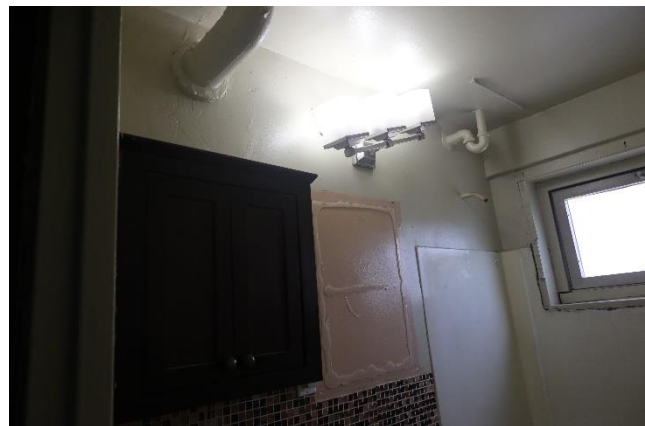
The bathrooms are basic, with a vanity, bathtub and toilet. They do not meet current accessibility requirements. Traps for the bathtubs and toilets extend through the floor slab and are visible in the apartment below. The floor in the bathrooms observed have ceramic tile of varying sizes depending on the unit (e.g. a 12” x 12” square or small ceramic tiles). The walls are typically painted, though in some units they have tile on select walls. The bathtub surrounds observed are a continuous fiberglass reinforced plastic. The sinks are wall mounted and there is a mirrored medicine cabinet above. There are often leaks from the floor above and from the exterior walls causing a significant amount of finish damage in the bathrooms.

Building 7 bathroom with exposed traps.

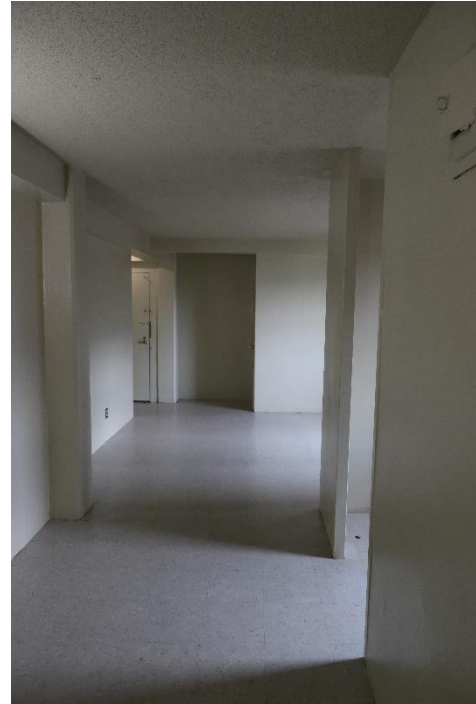
Typically, the apartments appear to have vinyl composite tile throughout. There was no asbestos tile observed in the apartments. The plaster walls show their age with buildup of paint and an uneven surface. Ceilings are plaster applied directly to the concrete slab above. Interior apartment doors typically do not appear to be original and to have been replaced with hollow-core wood doors.

Building 18 apartment interior.

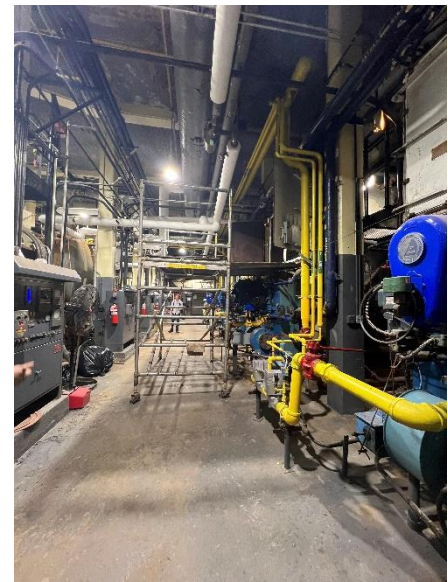
2.5.1.1. The Central Boiler Plant Steam provides steam throughout the campus for heating and domestic hot water. It is served by the boiler plant consisting of the original (6) dual-fuel (gas/oil) boilers, and it is located in Building 13 (819 FDR Drive). A temporary boiler is present on the site given (5) out of the (6) boilers were not operating. The boiler plant is more than (70) years old and beyond its useful service life.

Boiler Room at Building 13
