Jacob Riis Houses Community Planning Process – Resident Meetings: Meeting 7 on October 22 + Meeting 8 on October 29, 2024

Riis Tenants Association + BFJ Planning + New York City Housing Authority + Nelligan White Architects

Existing Conditions Assessment

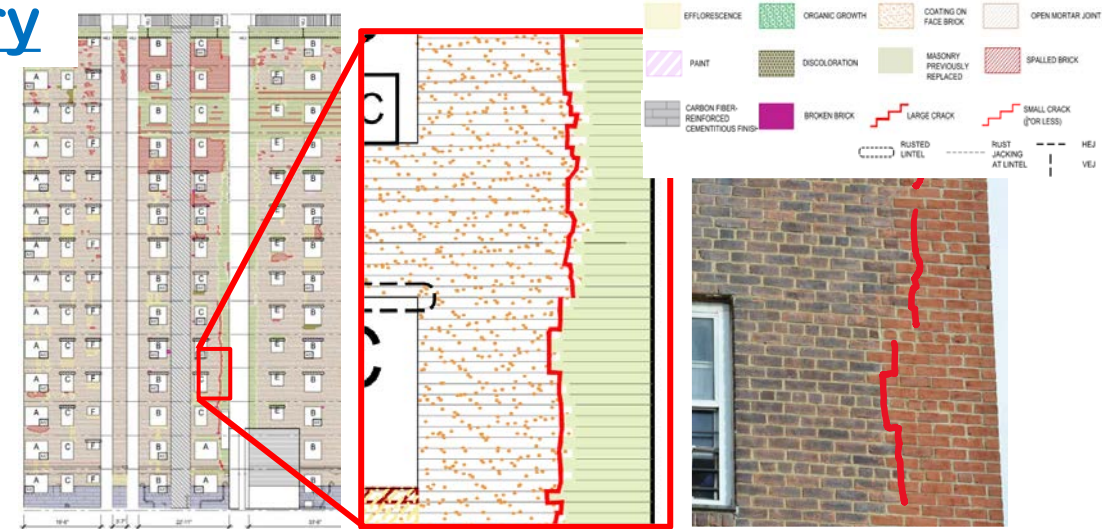
Building 5 (1141 FDR Drive) Damage Mapping

- Brick damage is extensive, more than usual due to the location.
- Some incremental brick repairs may be possible in places; in others, full brick replacement or over-cladding is required.
- The exterior walls have no insulation, making the buildings energy inefficient and difficult for residents to control interior temperatures.

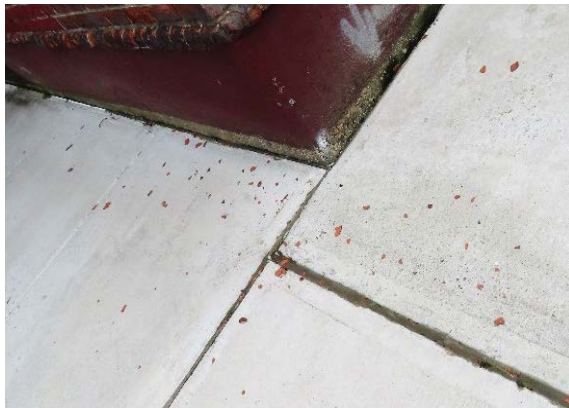
Pieces of brick spalls on the sidewalk

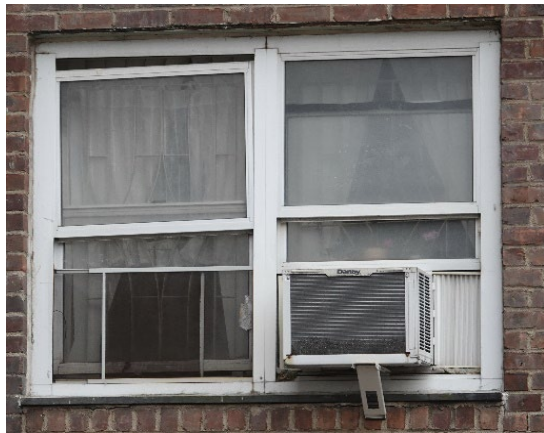
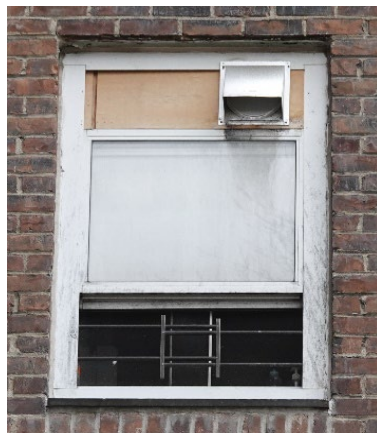
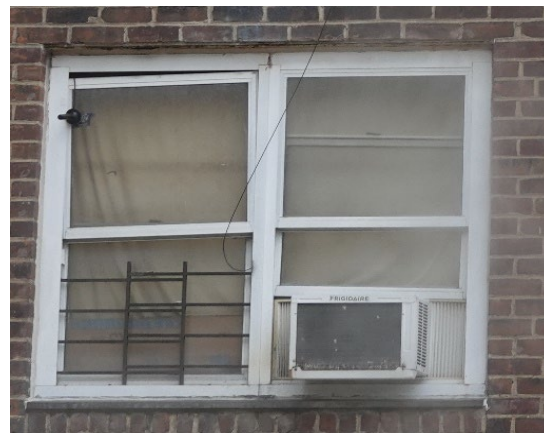
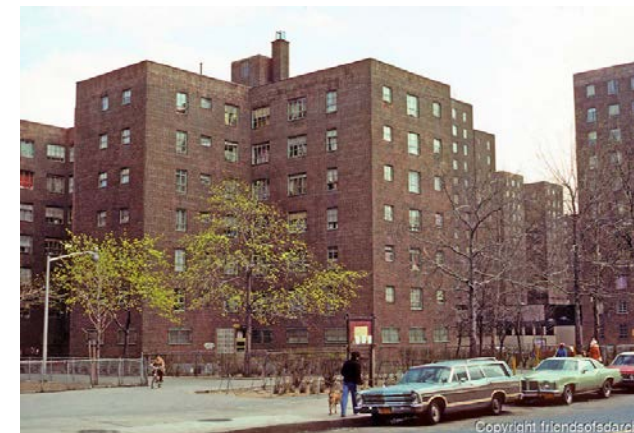
Windows were installed in 1982 and must be replaced with new windows that comply with current energy codes and match the original window appearance.

Riis Houses Windows Current Condition

Riis Houses Original Windows

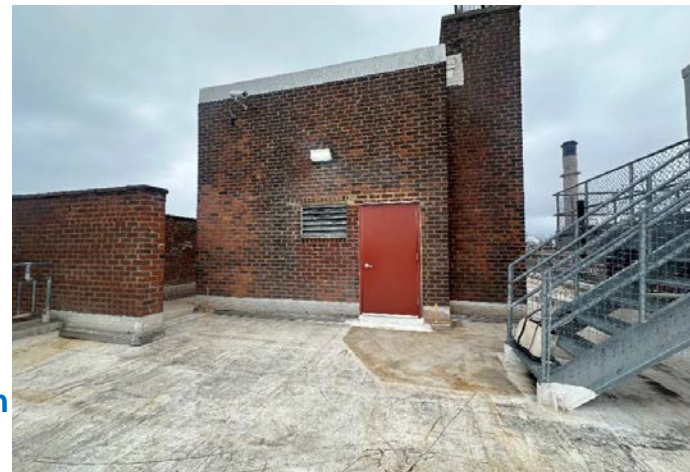
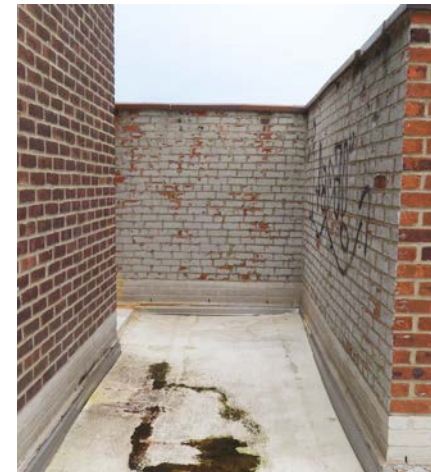
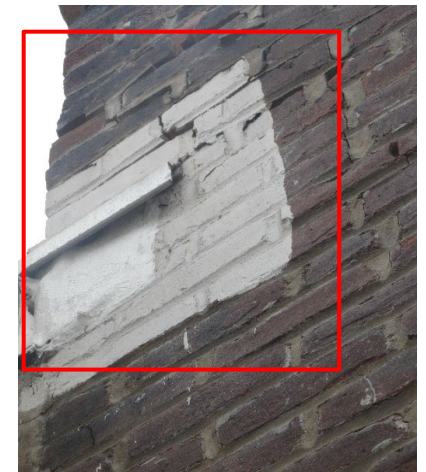
Most of the roofs have recently been replaced, but repairs are necessary to address ponding and leaks.

The source of leaks at top floors is from parapets. Parapets must be replaced.

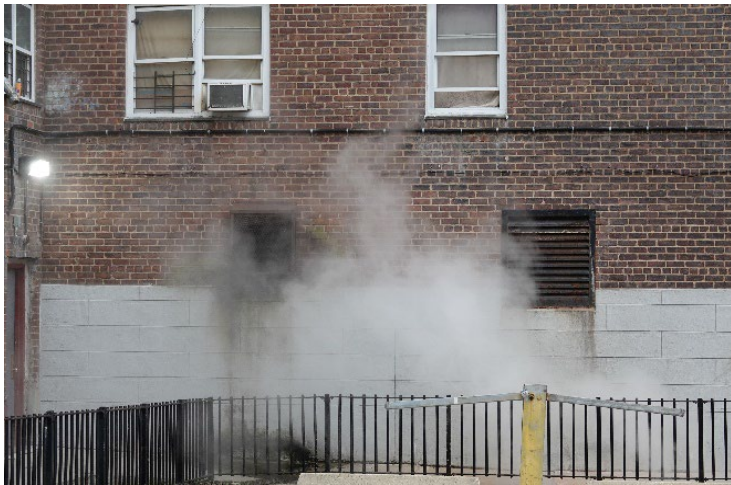
**Steam leak at Building 4
(1225 FDR Drive)**

- Electrical, plumbing, and elevator systems are beyond their useful life and must be replaced.
- The steam heating system will likely require full replacement.
- There is opportunity to consider modern systems that incorporate, heating, cooling, and ventilation.

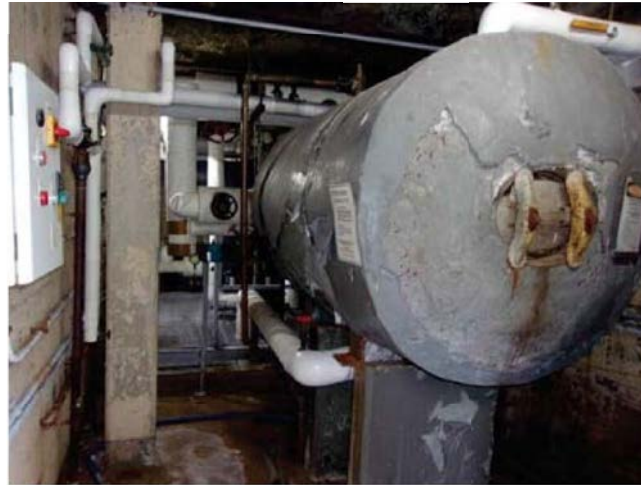
**Steam to water generator and hot water
storage tank system in Building 9**

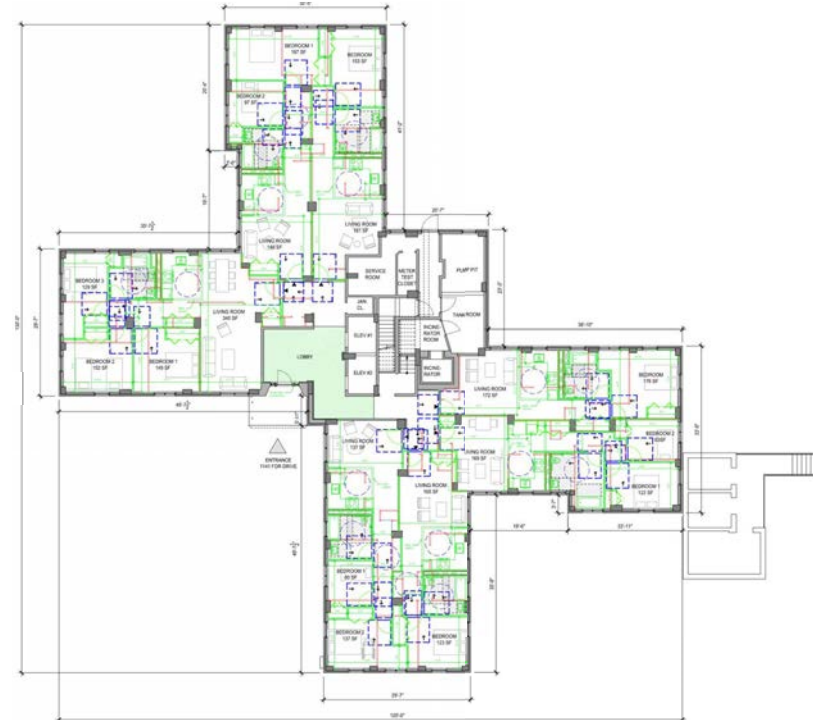
Type B Building – ground floor units (2, 3, 5, 6, 13, 15, 18)

In total, **(28) units** could be made accessible on the ground floor of these buildings, by reconfiguring the entire layout.

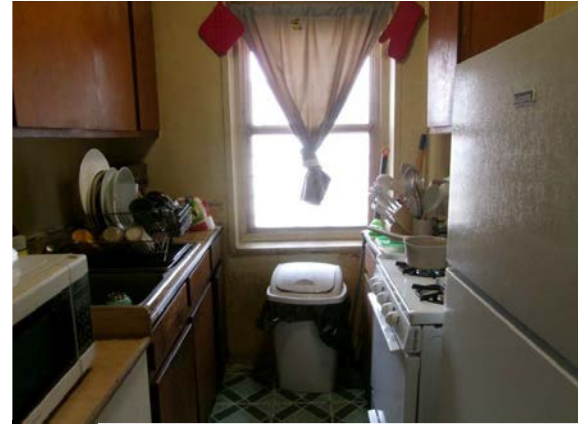
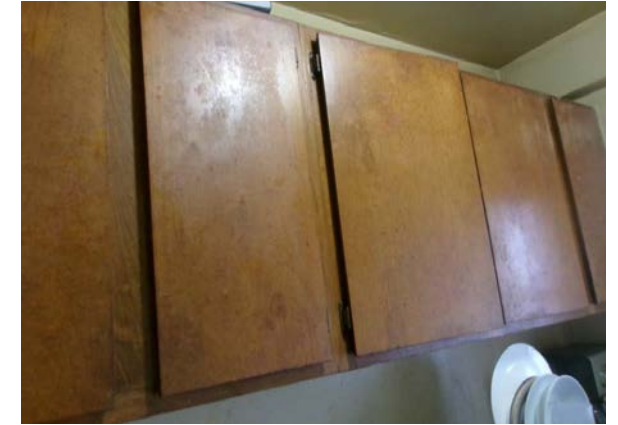
- Kitchens and bathrooms must be replaced.
- Floors and walls must be waterproofed.
- Plumbing risers and pipes must be repaired or replaced.
- Electrical service will likely need to be upgraded.

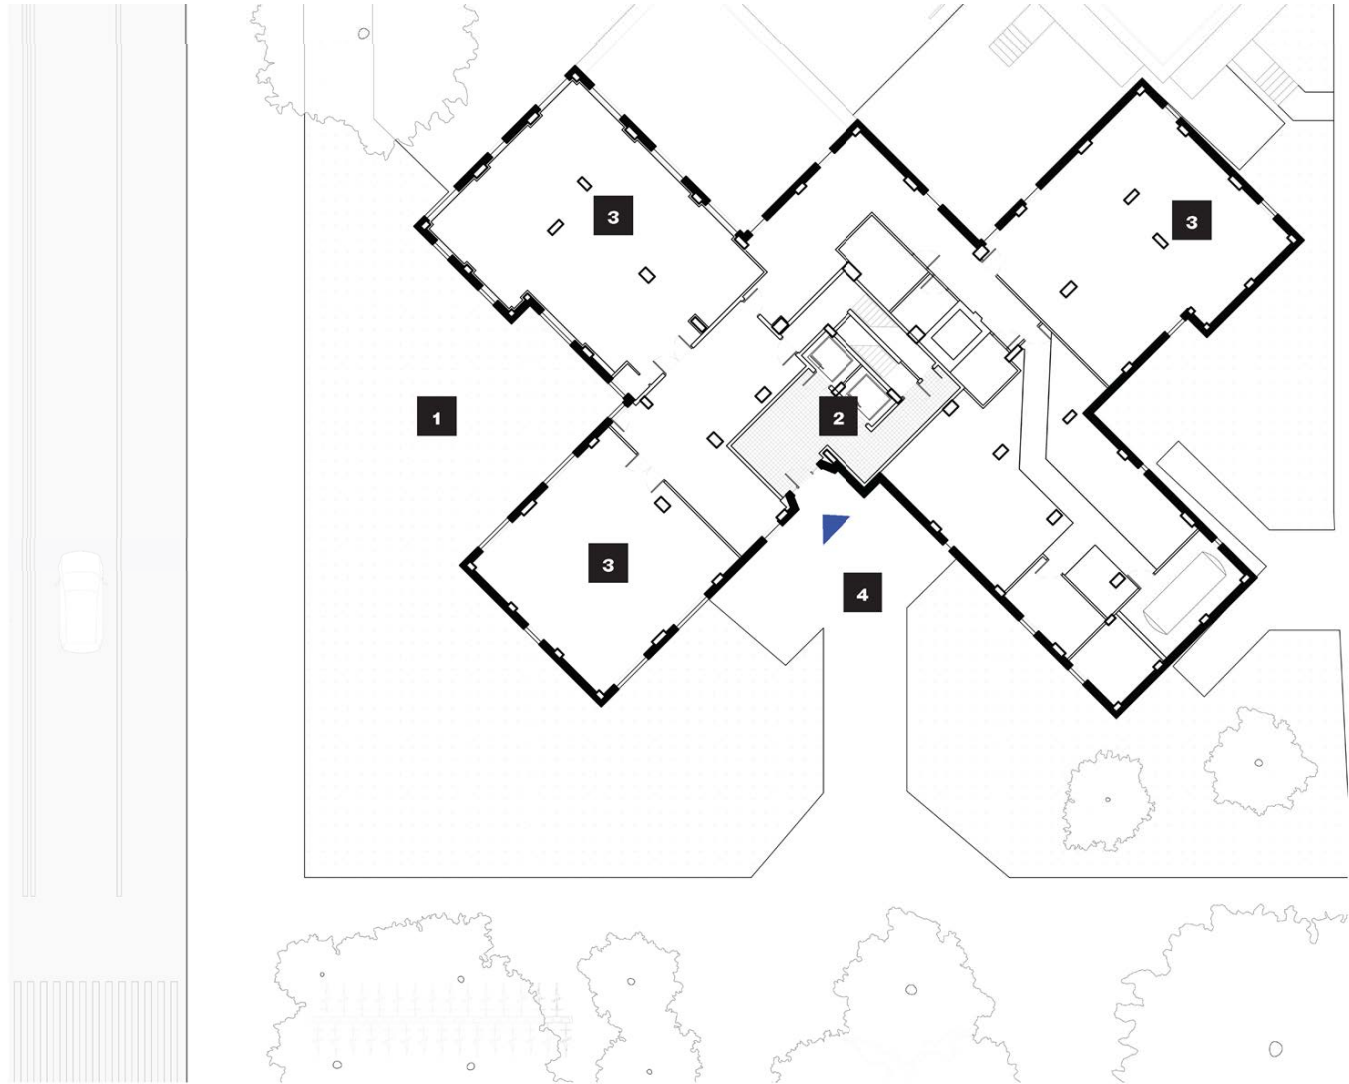
Existing Plan

Existing building layout is removed from sidewalk, isolating Riis from the rest of the neighborhood.

Existing lobbies are small, lacking security features and generally insufficient for 21st century needs.

There are opportunities to reprogram the ground floor to better serve residents.

The existing entry sequence does not permit a zone for residents to gather.

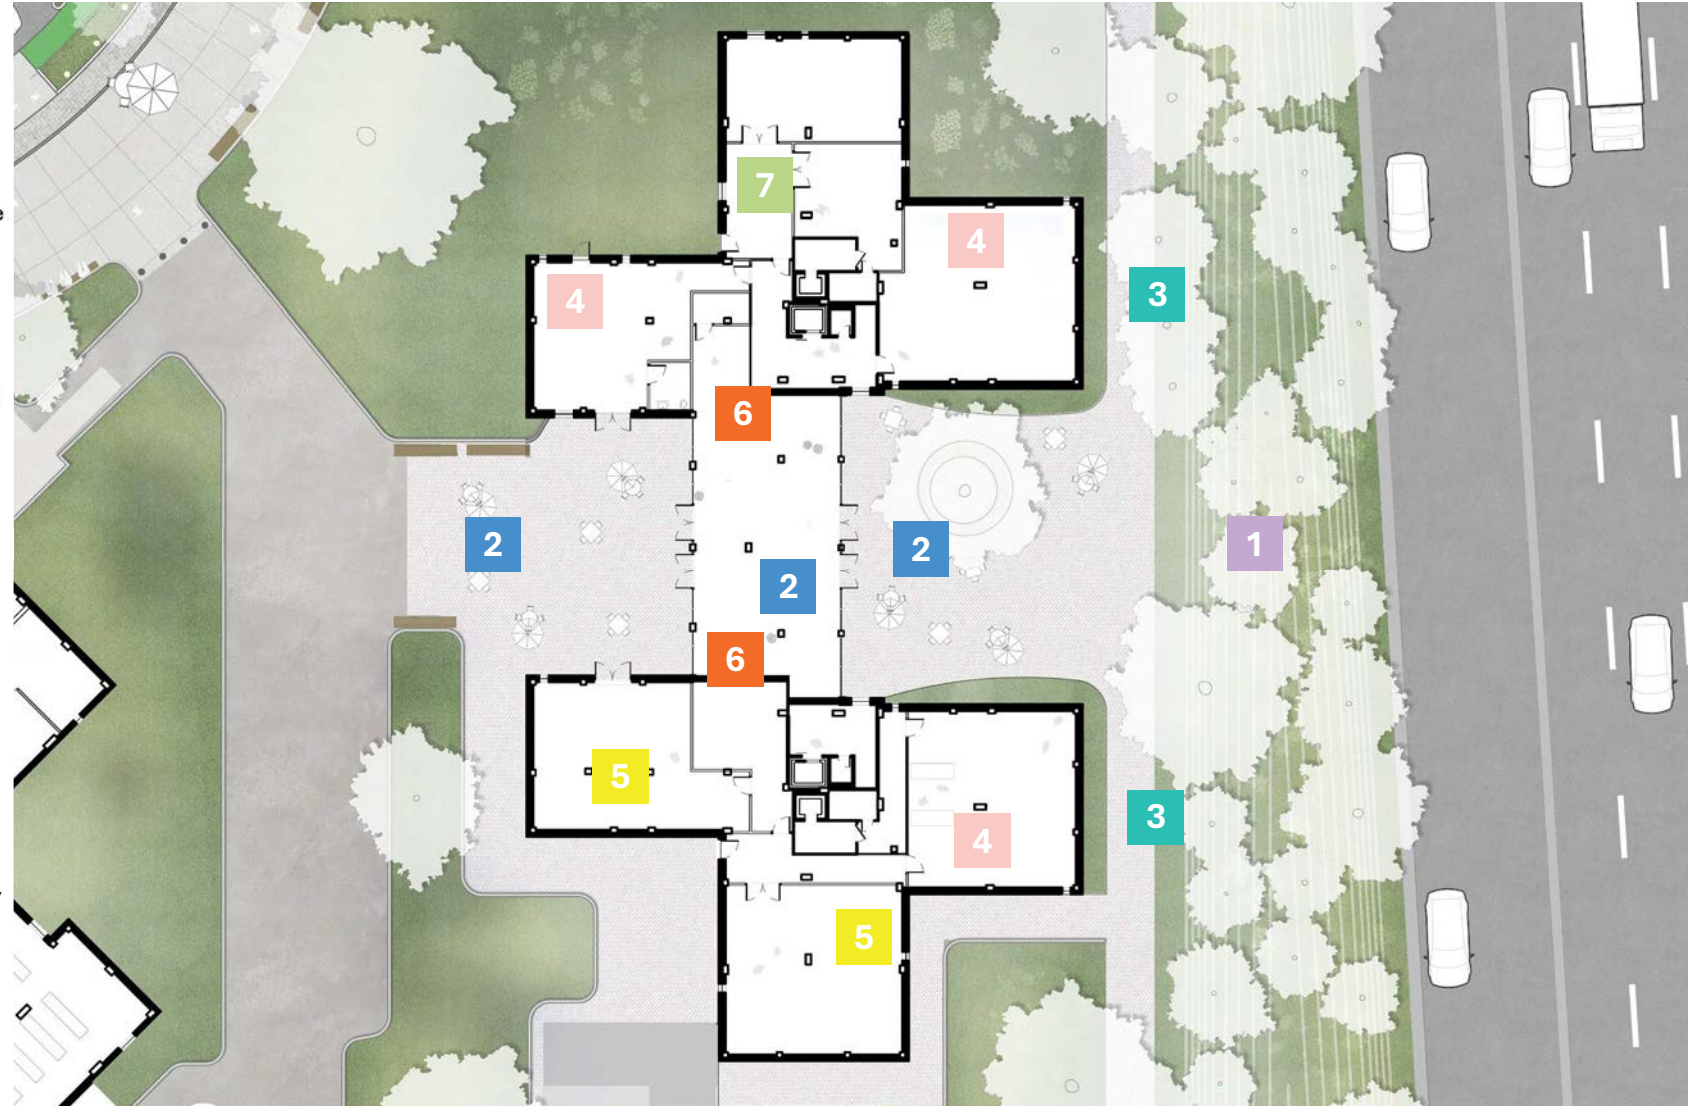
Proposed Program Updates

- 1 Vegetative Buffer**
Building up the side of the road and planting dense shrubs can protect residents from the pollution of the FDR.
- 2 Lobby and Entry**
Enlarged lobby allows for mail & package rooms as well as a new security desk. The lobby opens up to outdoor patios, allowing space for gathering.
- 3 Nature Walk Path**
Shifting the sidewalk inboard of the vegetative buffer shields residents from the highway.
- 4 Enhanced Resident Program**
Better utilizing the ground floor can open opportunities for resident amenities such as a Senior Center, laundry room, tenant storage and more.
- 5 Community Amenities**
Additional space may be available to offer community benefits like a food pantry or job training facility.
- 6 Security and Mail**
- 7 Back of House Upgrades**

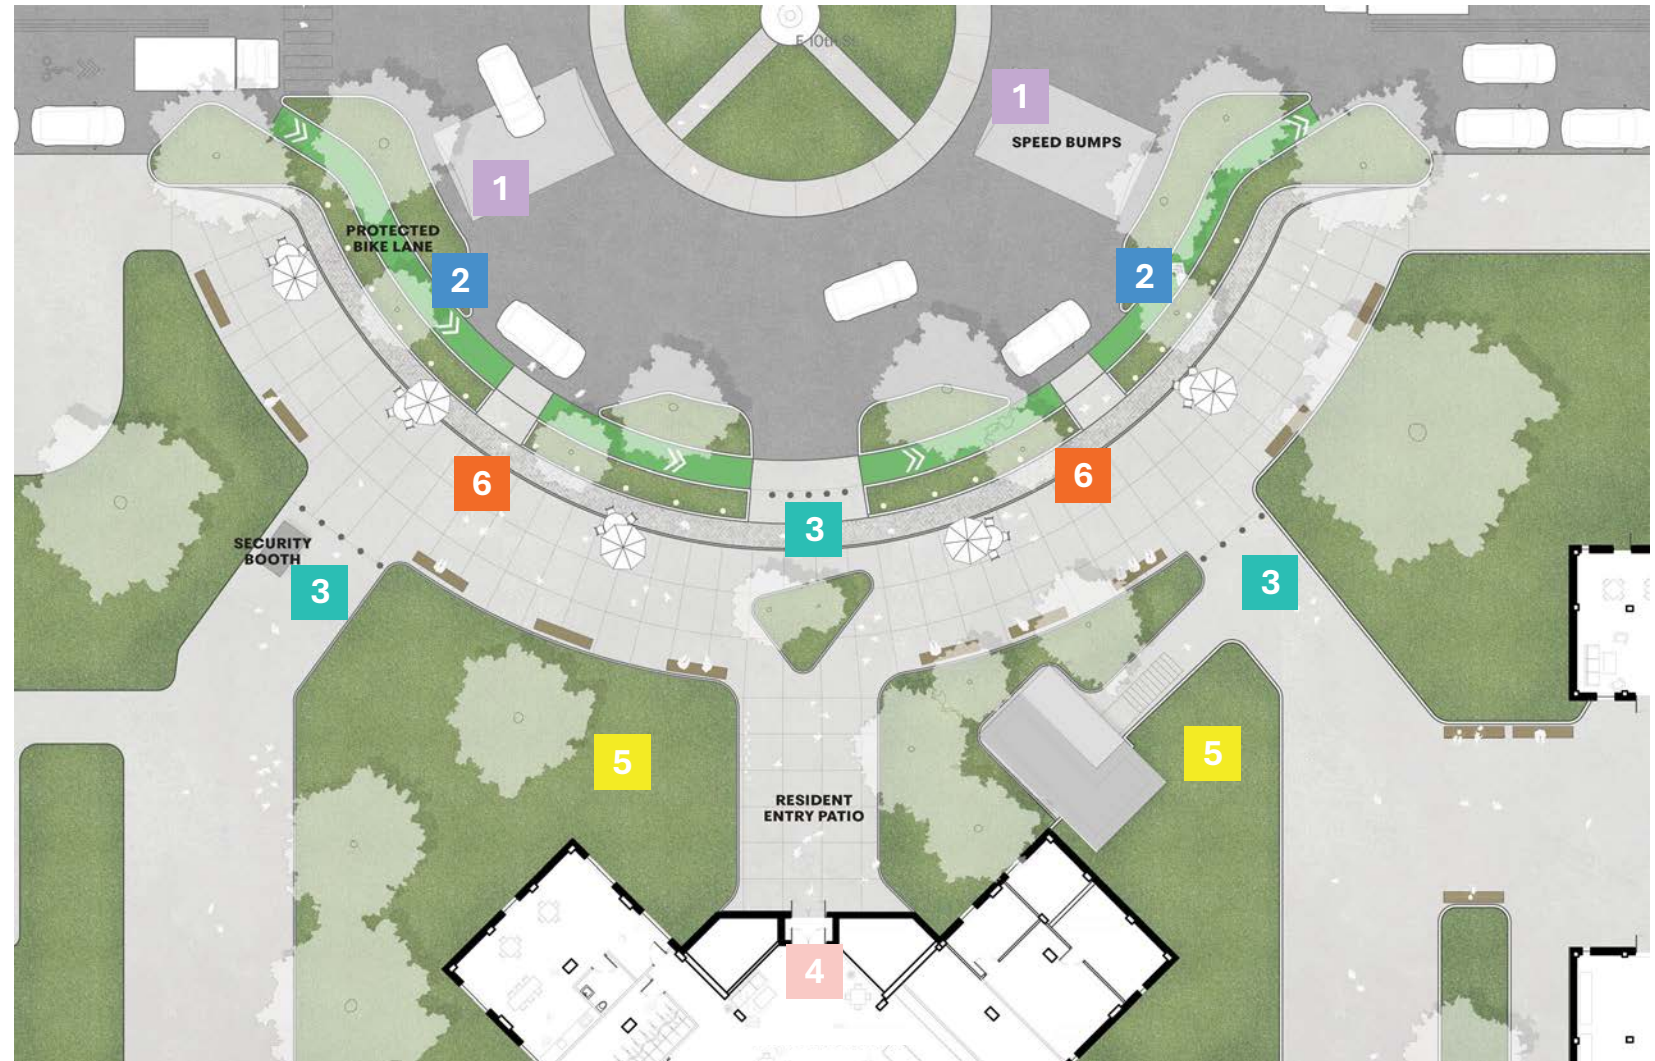
Proposed Program Updates

- 1 Traffic Calming**
Implementing measures like speed bumps and landscaped plant beds can effectively reduce vehicle speeds and create a safer environment.
- 2 Protected Bike Lane**
Designating a protected bike lane can enhance cyclist safety while also creating a wider buffer between pedestrian entrances and the roadway.
- 3 Security Booth and Bollards**
A staffed security booth, combined with strategically placed bollards, can provide enhanced oversight and control over site access.
- 4 Building Entry**
Extending the building's entry outward toward the street can create additional amenity space for residents and improve the connection to the street.
- 5 Landscape Improvements**
New planting to enhance public gathering spaces and residential entries.
- 6 Improved Site Lighting**
Upgrading the site lighting can improve visibility and safety, especially during evening hours.

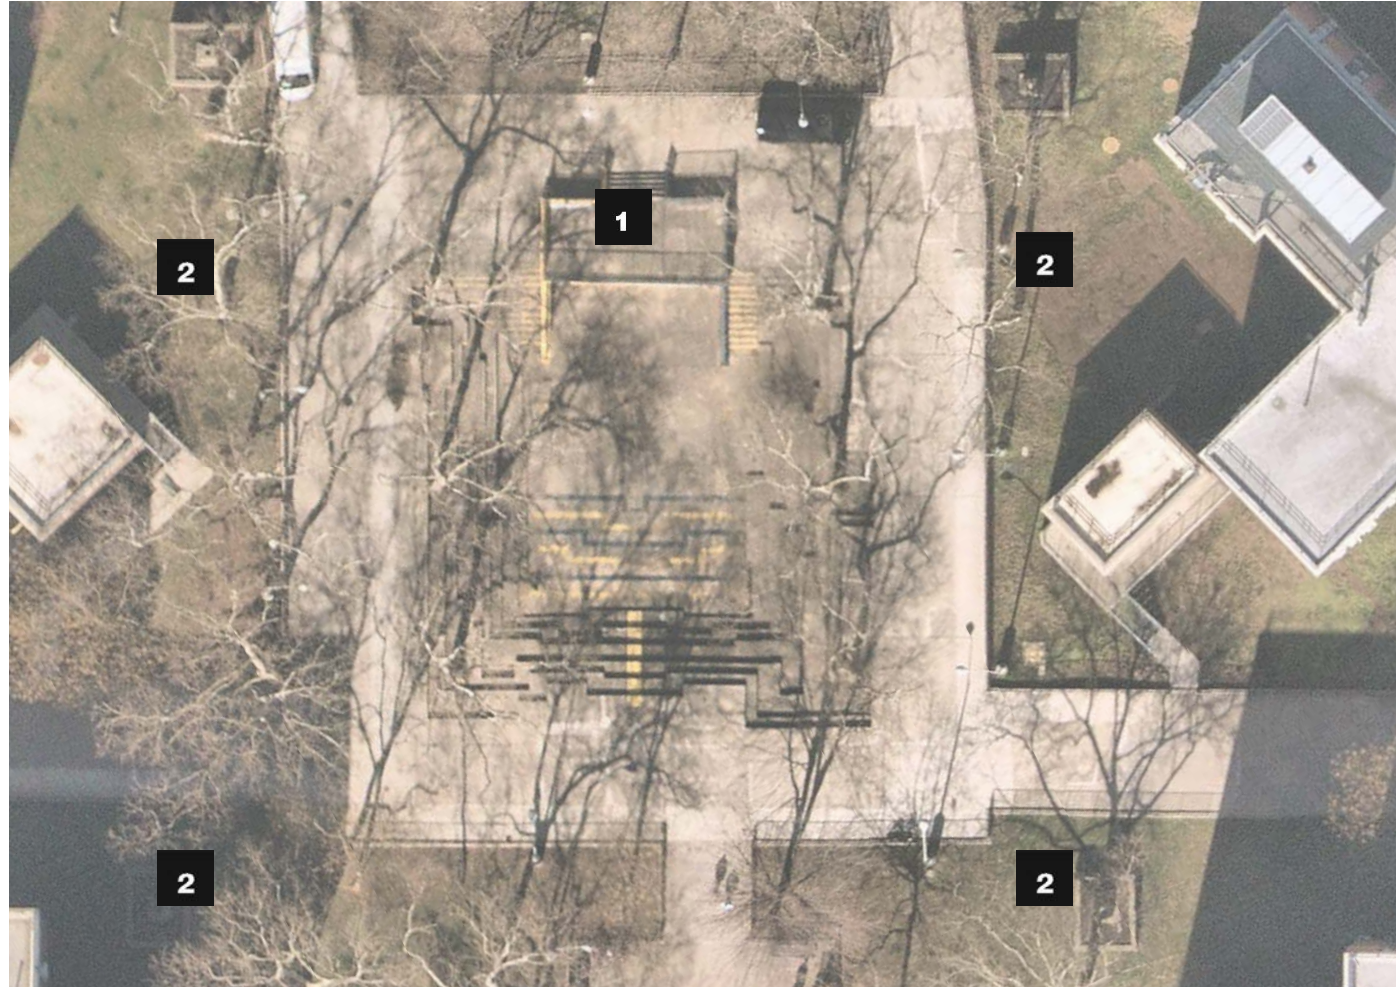
Existing Plan

The amphitheater is a site for the community to gather outdoors.

The historic trellis and residential site lighting have been removed from the amphitheater area, eliminating the memory of the space.

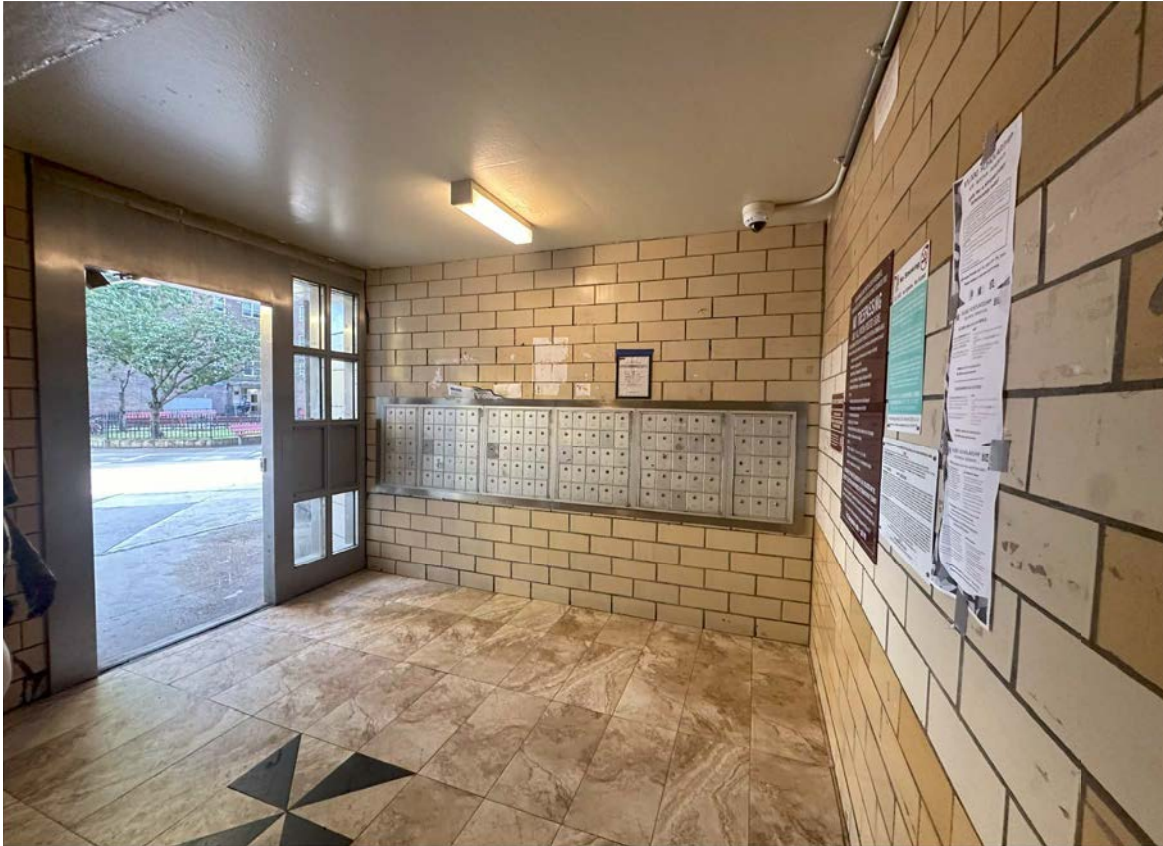
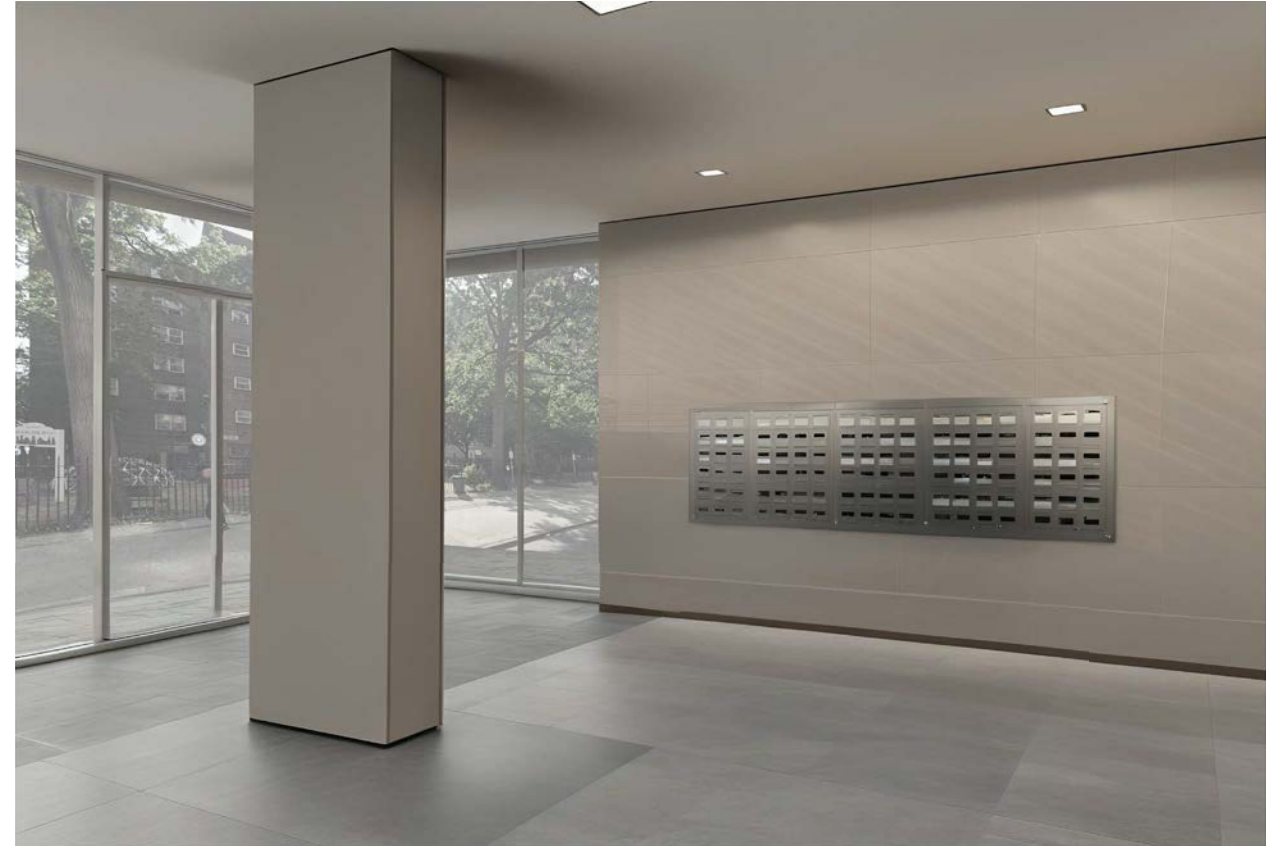
ENTRY

These images show before-and-after photo and example rendering of a fully renovated building lobby interior, including new flooring, wall treatment, lighting and mailboxes.

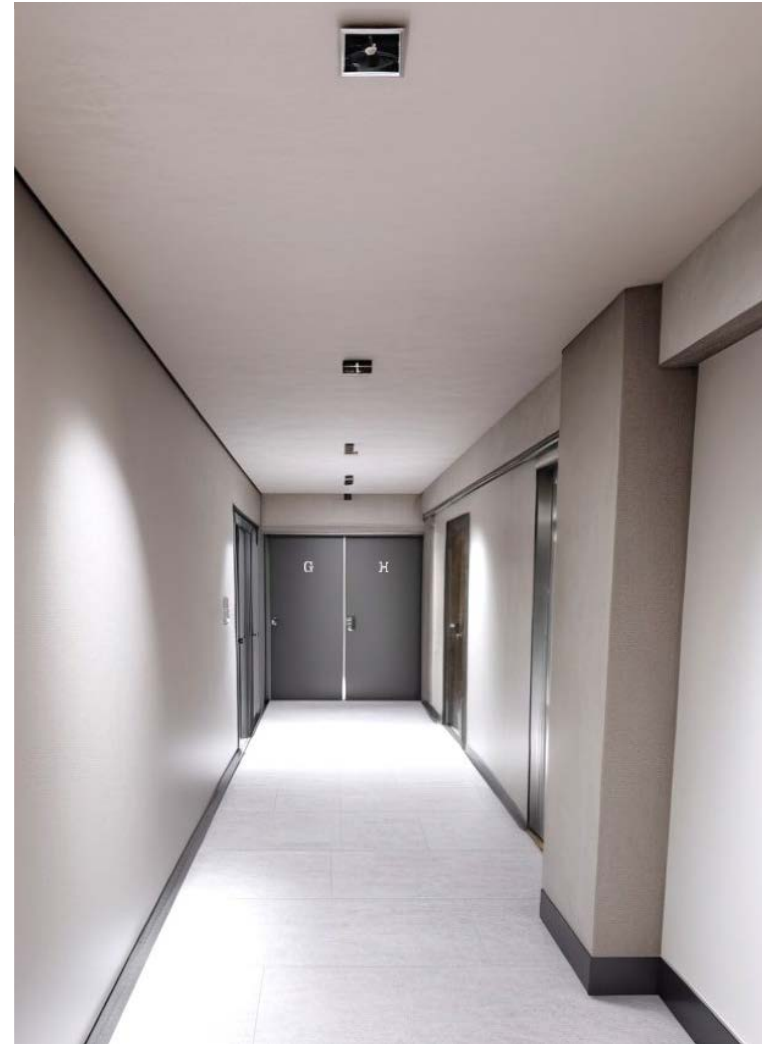
HALLWAY

These images show before-and-after example photo and rendering of a fully renovated building hallway, including new flooring, wall treatment, doors and lighting.

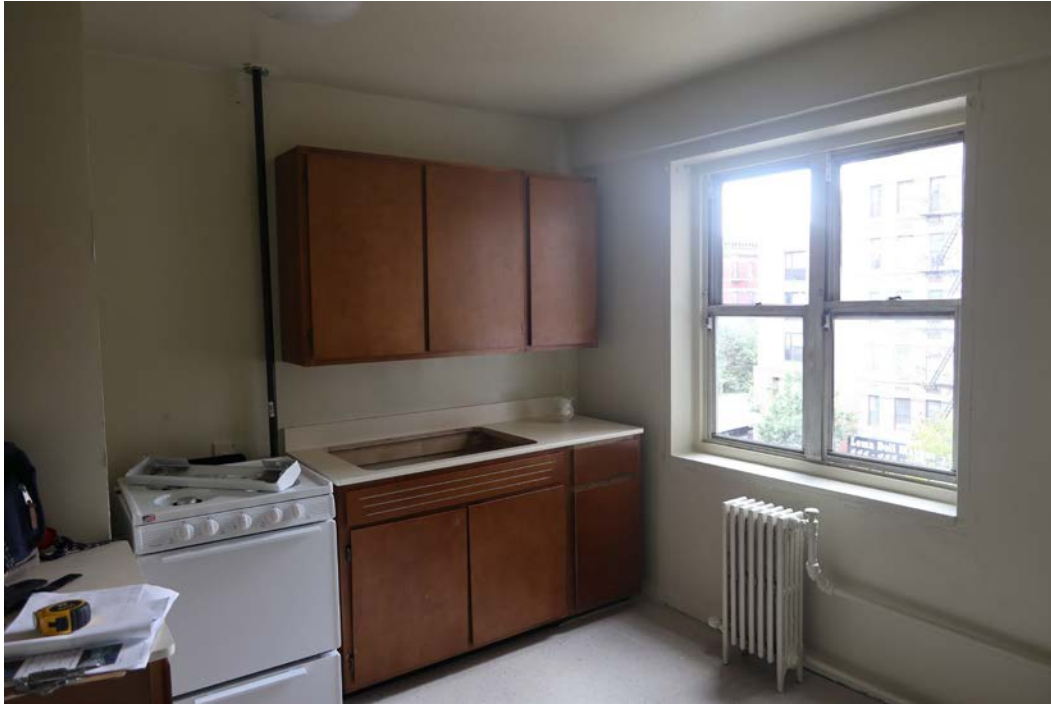
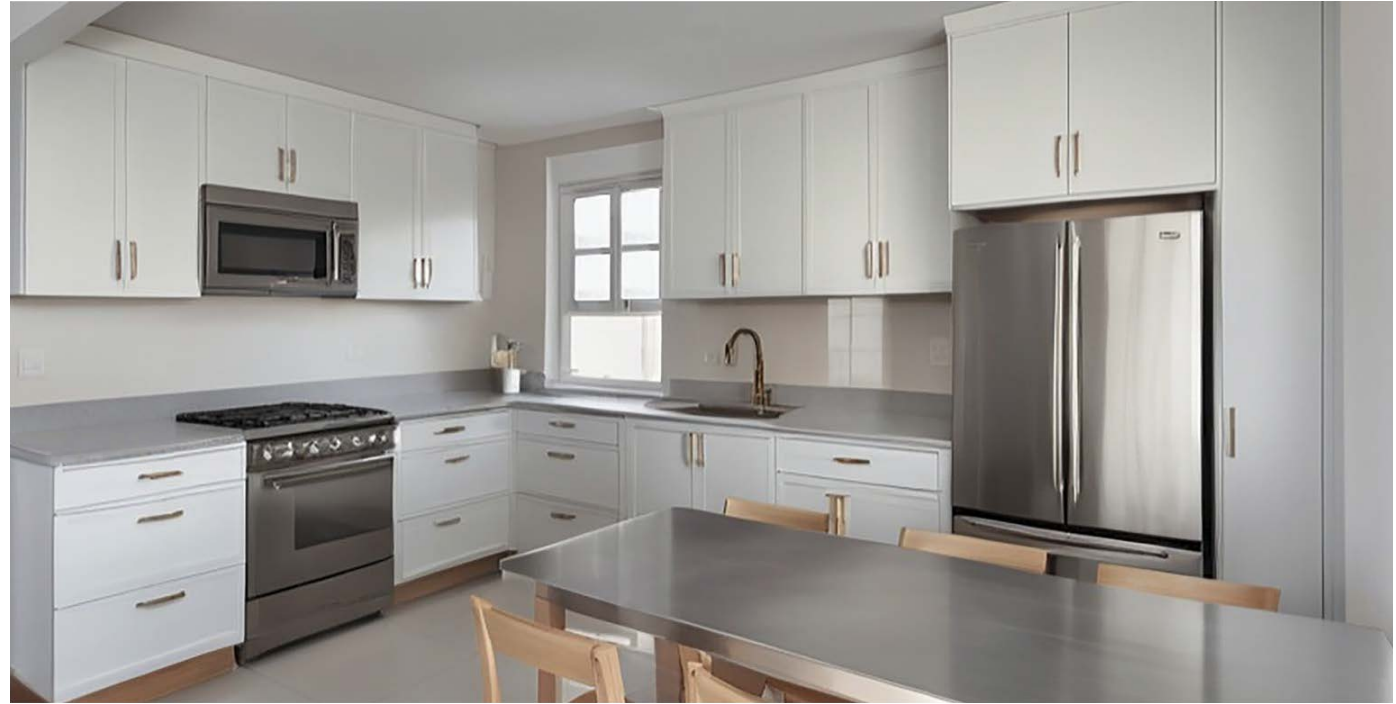
KITCHEN

These images show before-and-after photo and example rendering of a fully renovated apartment, including new flooring, appliances and kitchen cabinets along with electrical and plumbing upgrades.

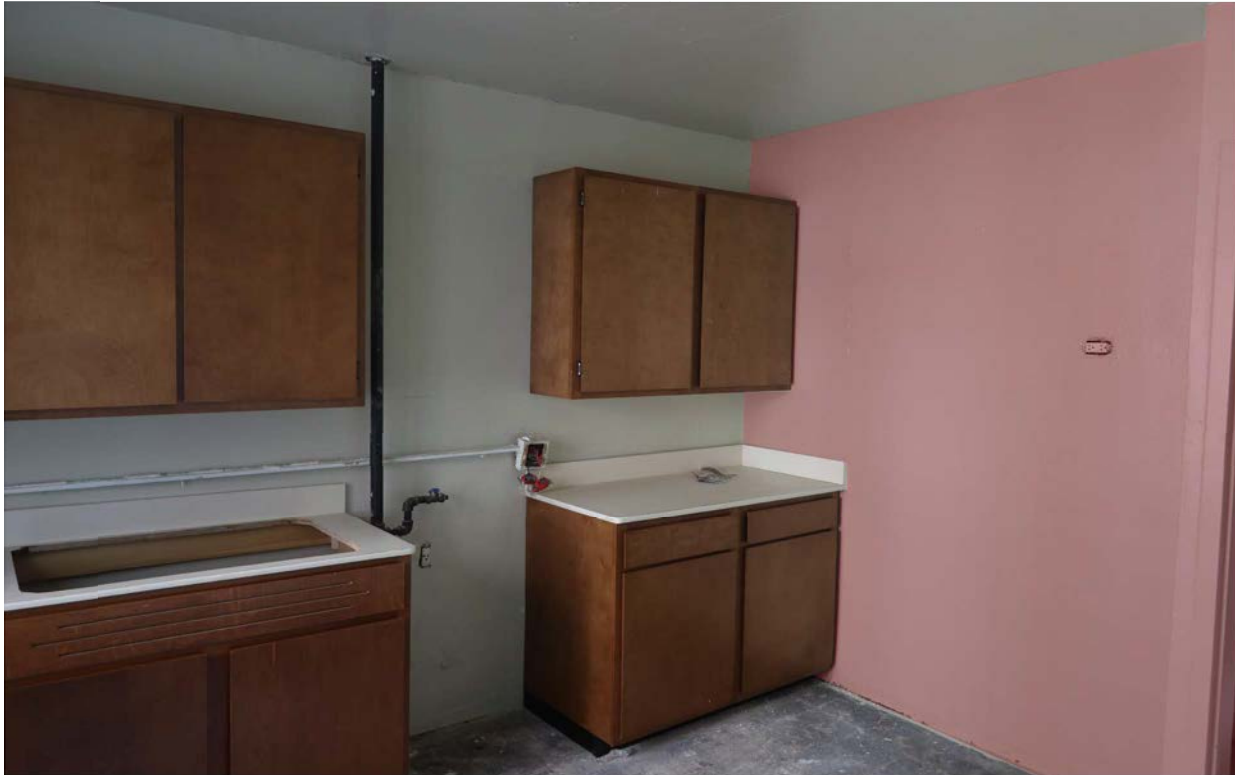
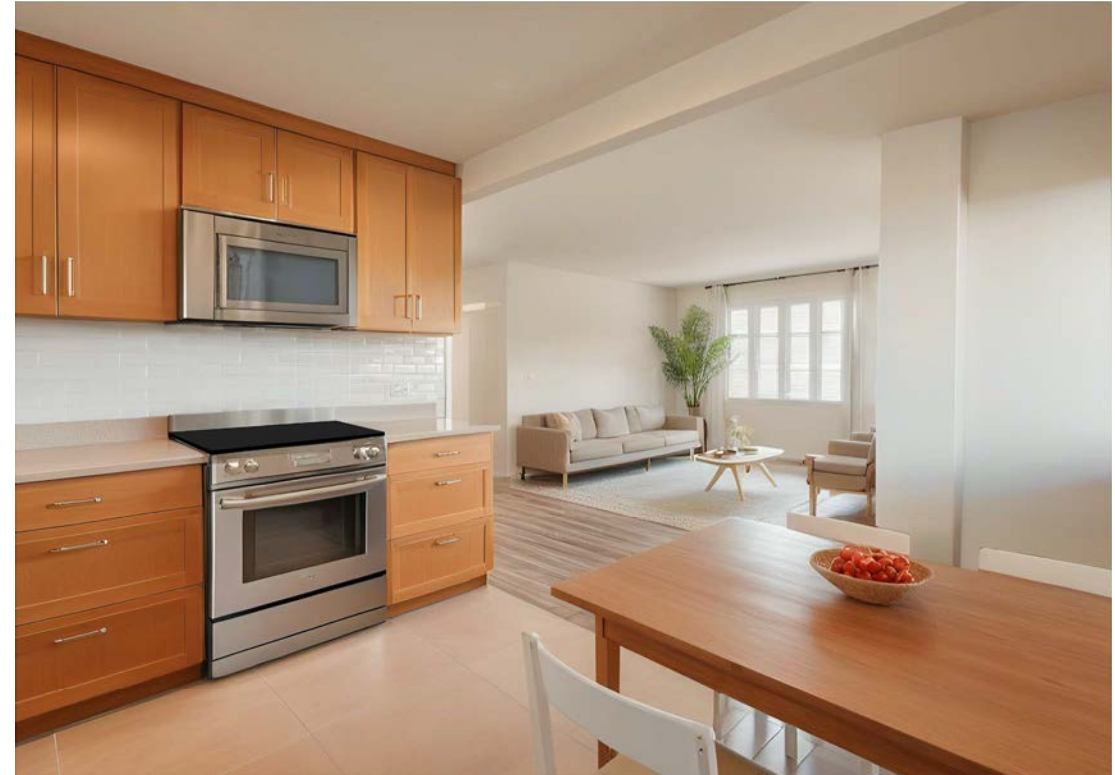
KITCHEN

These images show before-and-after photo and example rendering of a fully renovated apartment, including new flooring, appliances and kitchen cabinets along with electrical and plumbing upgrades. The pink wall could potentially be removed to open the apartment and create a more modern floor plan.

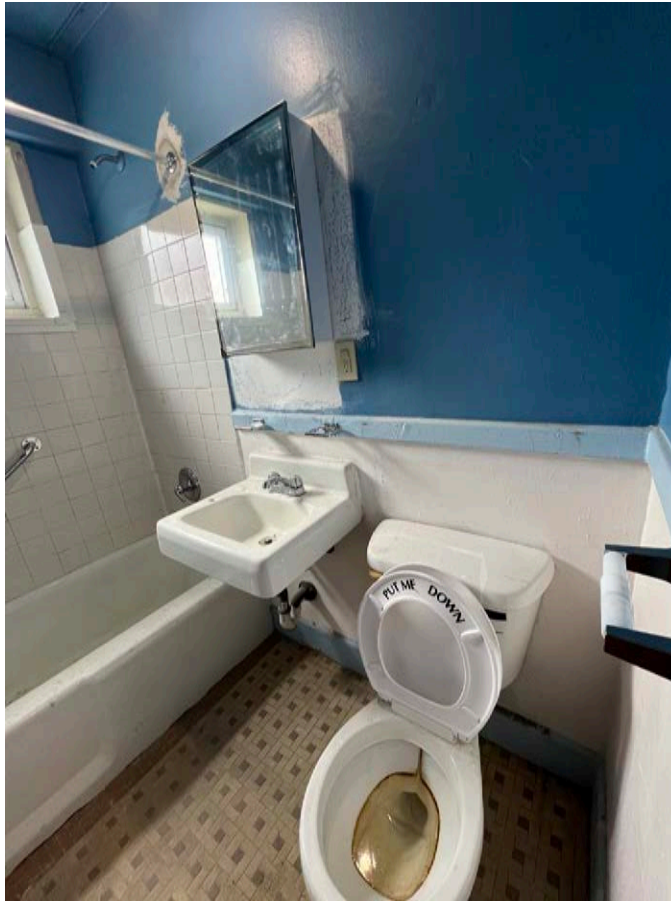
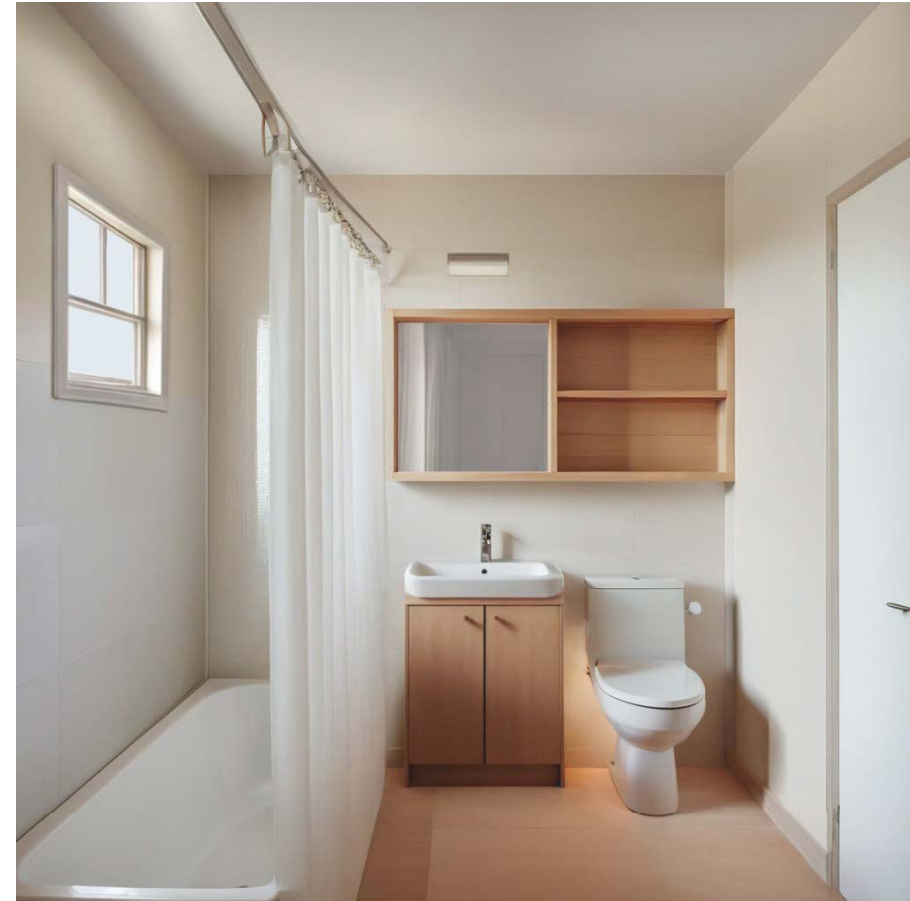
BATHROOM

These images show before-and-after photo and example rendering of a fully refurbished bathrooms with new plumbing fixtures, flooring and cabinets.
