Jacob Riis Houses

Existing Conditions Report

January 29, 2025, Final Draft

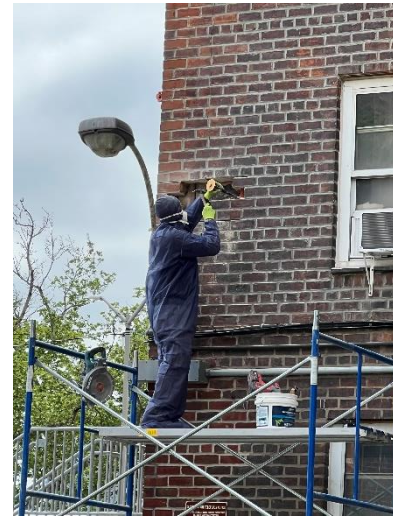
Masonry probe at Building 5

Bricks were removed at two locations, one Building 5 and one at Building 17, to provide sample bricks for laboratory testing and to allow NW to observe the conditions at two different buildings. Building 5 was selected as a mid-rise building located along the FDR and exposure to the river exhibiting a lot of physical deterioration. Building 17 was selected as a low-rise building located along Avenue D which exhibits the least physical deterioration.

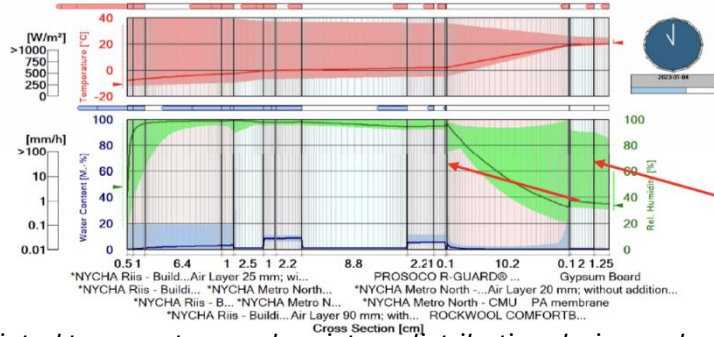
Predicted temperature and moisture distribution during early Winter. Computer Simulation graphic for Building 17

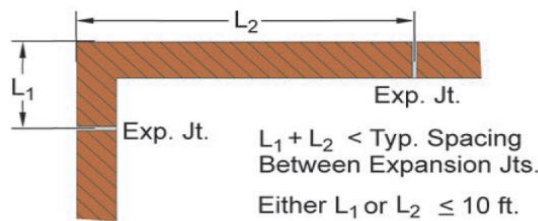
(b)

Proper Expansion Joint Locations at Corner

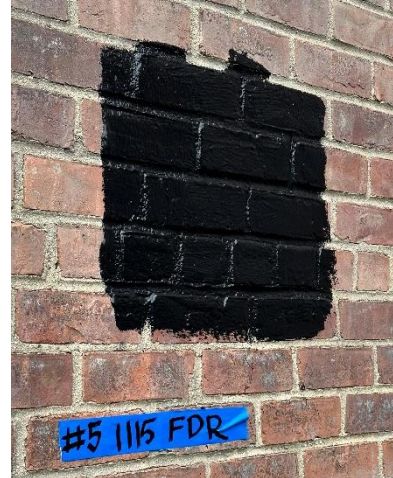
Waterproofing membrane installation for Adhesion Testing

To determine the feasibility of this potential solution, test installations of a fluid-applied membrane air barrier were made at (7) locations. The product applied was the Henry Air-Block STPE, a product well-suited for this application because it can weather UV exposure for up to (12) months (during construction) without degradation. In the test, the membrane passed in (5) of the (7) locations, an indication that the overclad strategy will be feasible.

It was determined through laboratory testing that the existing face brick will likely continue spalling because of inherent deficiencies. Insulating the interior of the masonry wall will aggravate this problem. Our recommendation would be to either replace the face brick, or to overclad the face brick. In the case where over-cladding is recommended, then the new assembly would include the application of a water-proof membrane that will also serve as an air barrier to the face of the existing brick, followed by at least (4) inches of mineral wool insulation and some form of rainscreen cladding.

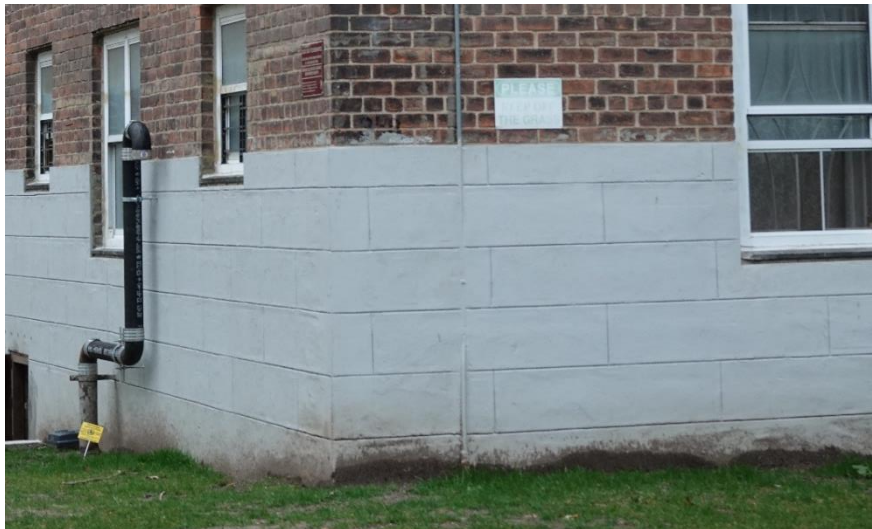
New stucco at the foundation walls was installed at select locations as part of the Hurricane Sandy Recovery + Resilience work designed by LiRo, construction management by STV, and construction by General Contractors WDF at Riis I and DMD at Riis II. LiRo Drawings indicate that the stucco is reinforced with carbon fiber in some locations and is intended to provide structural resistance to hydrostatic loads during future flood events, like Hurricane Sandy, which flooded most of the site to an approximate elevation of 11.0' NAVD88.

Carbon fiber reinforced cement plaster

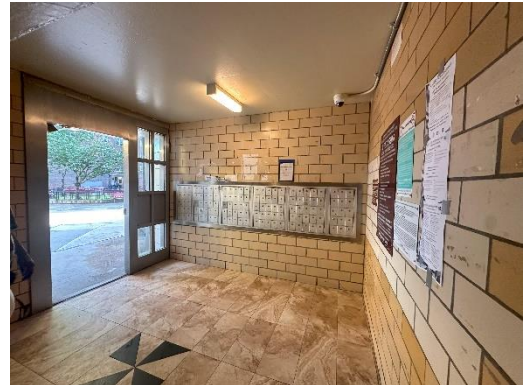
Building 5 Lobby

The building entries and lobbies are typical of older NYCHA developments. The entries themselves are a robust stainless steel and glass assembly with layered access; though, in NW's observation and experience, the doors are often left open, negating the benefit of a controlled access system. While some residents have reported broken locks, it has been NW's observation that the locks were in working order. The interiors of Buildings 5 and 12 walls are finished with beige structural facing tiles. The floor finish appears to be faux-marble porcelain tile recently installed.

The ceiling appears to be the painted underside of the structural concrete slab. Lights, conduit and security cameras are mounted to the underside of the slabs. The mailboxes do comply with current US Postal Service STD-4B+, but do not comply with current accessibility requirements (NYC Building Code, ADA/ICC A117.1 2009). Heat is provided via radiators hung from the ceilings.

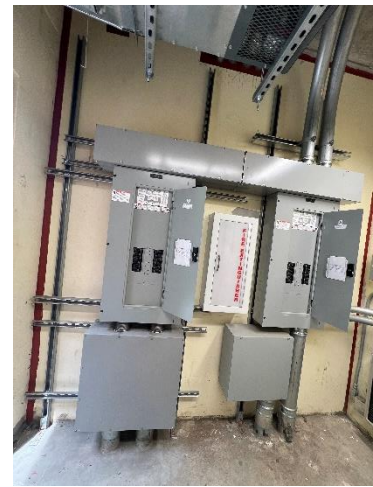
Electrical panel Room at Building 12

The electrical rooms for buildings with a generator installed were upgraded during the NYCHA Hurricane Sandy R+R Project and are located above grade level. New feeders were provided between the new electrical room and pull boxes serving the apartment risers as well as all the mechanical/house loads. However, neither the apartment risers nor the house load feeders were replaced as part of the Sandy project.

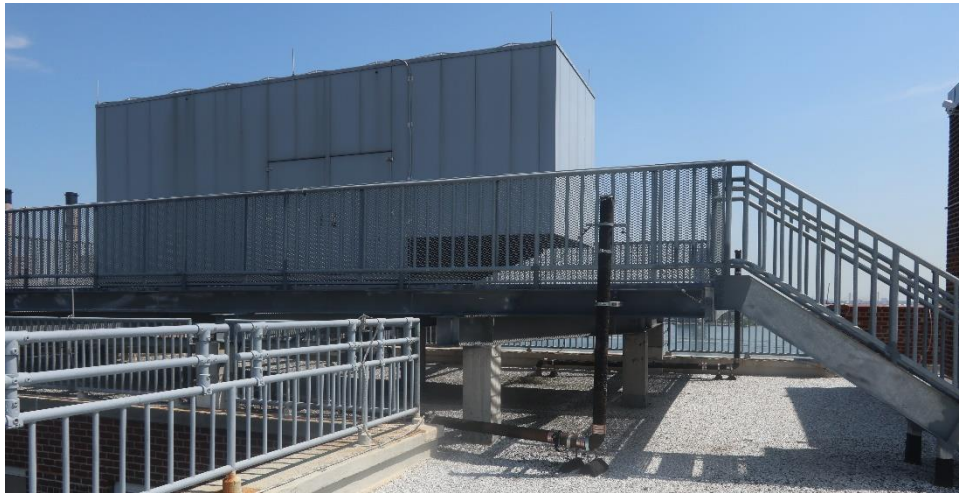
Roof generator at Building 14

Buildings 1, 2, 3, 4, 5, 6, 7, 8, 10, 11, 12, 13, 14, 15, 18, and 19 are provided with a generator located on the roof. (Buildings 9, 16, and 17 do not have generators.) The generators serving Type A+AR buildings are rated at 200 KW and the generator serving Type B building is rated at 350KW. The generators are natural gas-fired and provide 100% back-up for all the loads in their respective buildings. See below for the emergency electrical distribution system information.
